CASE STUDY

SLURRY TRENCH SEEPAGE BARRIER

KINGSTON NORTH-SOUTH ARTERIAL

DELAWARE AVENUE INTERCHANGE

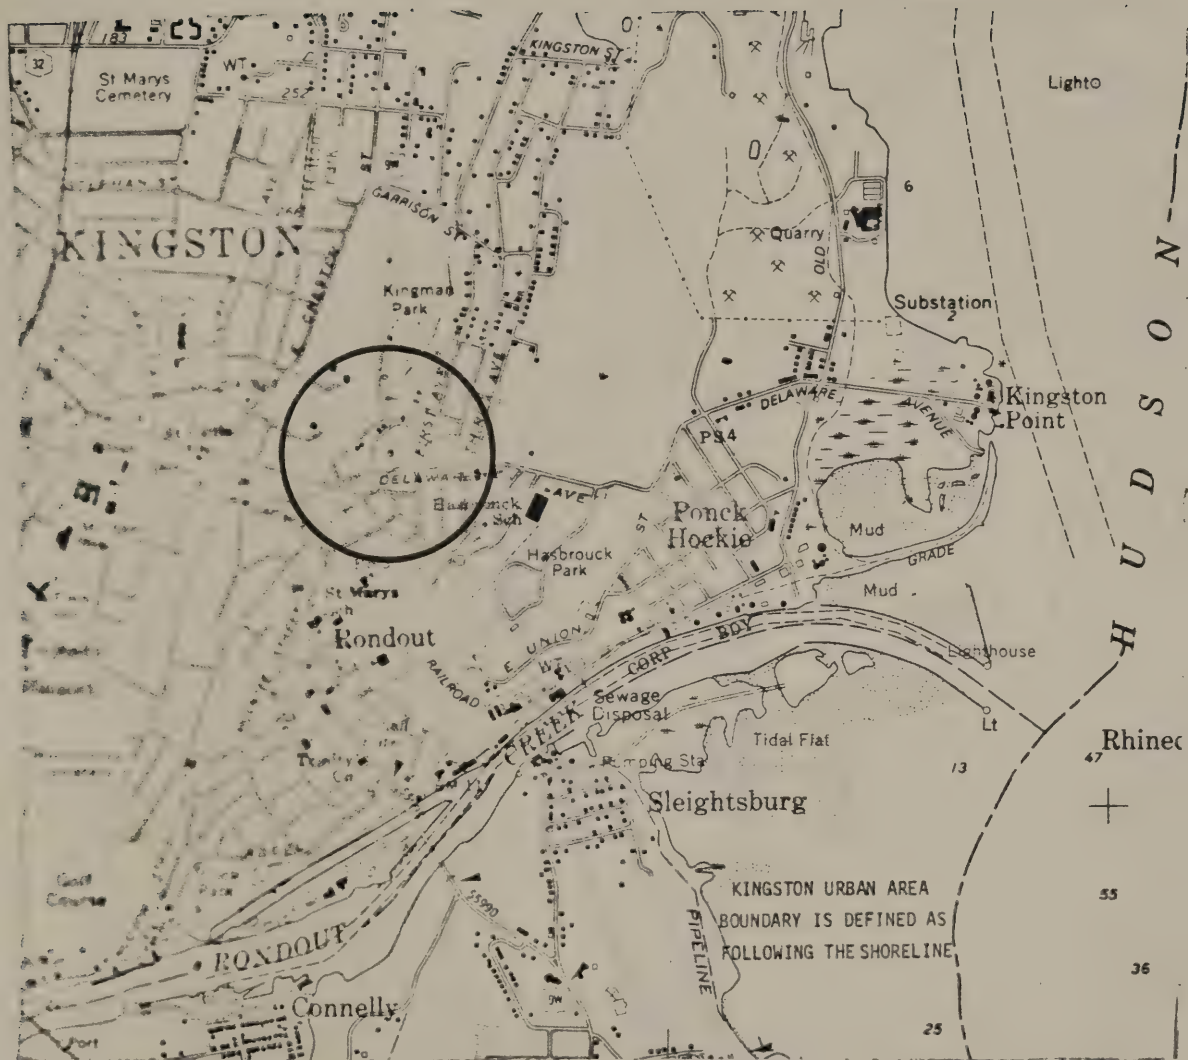
FIGURE 1

In April of 1979, Contract D95913 was let for a portion of the Kingston North-South Arterial. The construction consisted of a small piece of main-line pavement (.46 mi.) and a complete interchange with Delaware Avenue. Figure 1 indicates the general location of the project while Figure 2 shows the actual problem area.

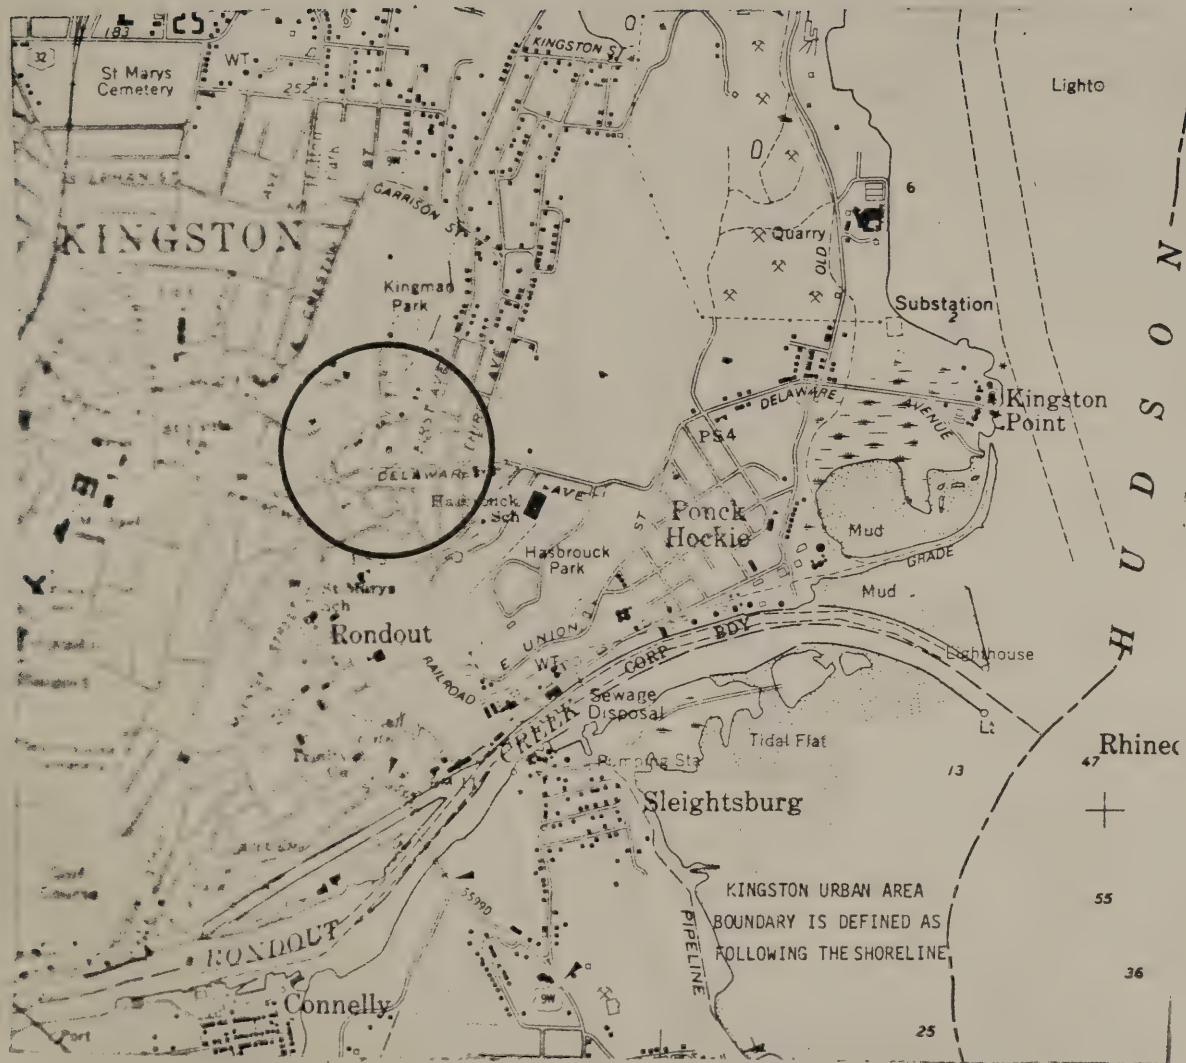
FIGURE 1

In April of 1979, Contract D95913 was let for a portion of the Kingston North-South Arterial. The construction consisted of a small piece of main-line pavement (.46 mi.) and a complete interchange with Delaware Avenue. Figure 1 indicates the general location of the project while Figure 2 shows the actual problem area.
